Sacred Trinity Church, Salford

Feasibility Study
November 2024

Project name: Sacred Trinity Church , Salford

Client: The PCC of Sacred Trinity Church, Salford

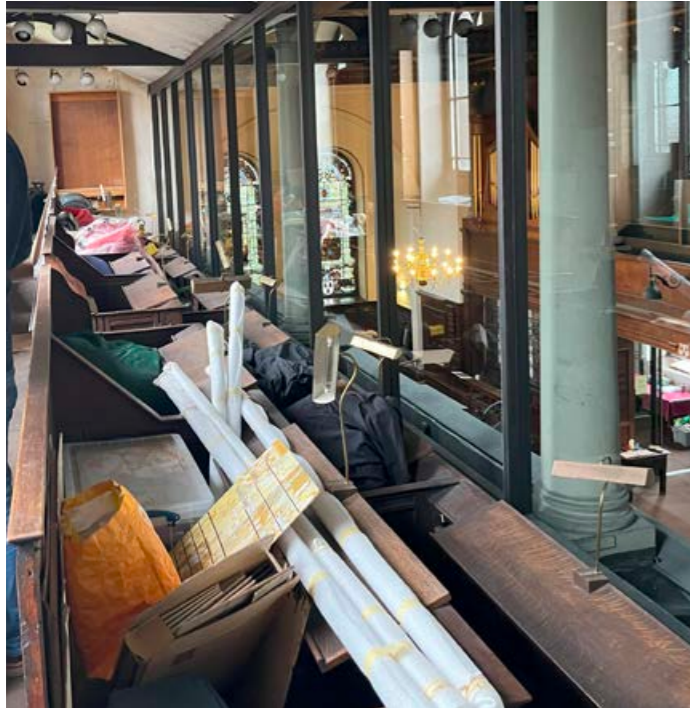
The gallery houses the oldest collection of church furniture in Greater Manchester, dating back to 1690. However, these spaces are underutilized as storage. Additionally, existing level changes make the gallery floor inaccessible to non-ambulant users.

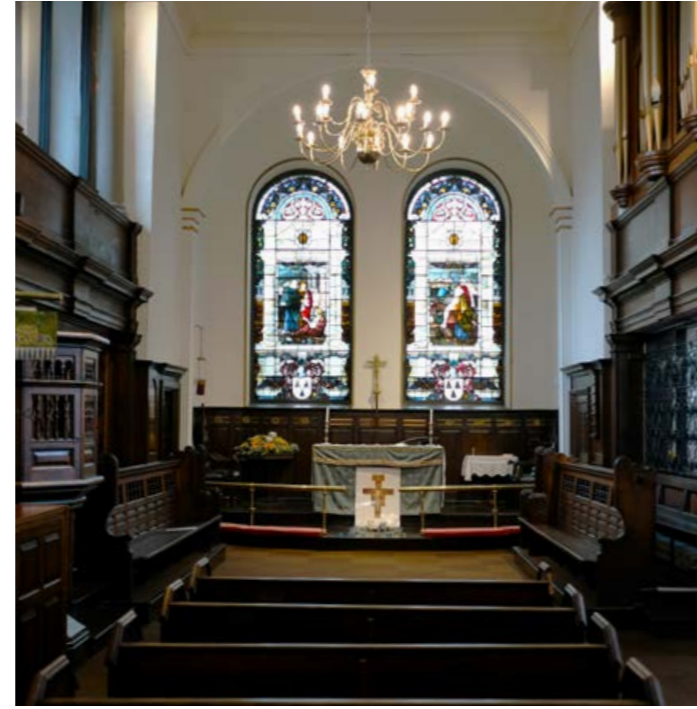
The chancel forms the central focal point of the church, with ornate arched windows, gallery organ and Jacobean pulpit. This eastern part of the church is the primary liturgical space.

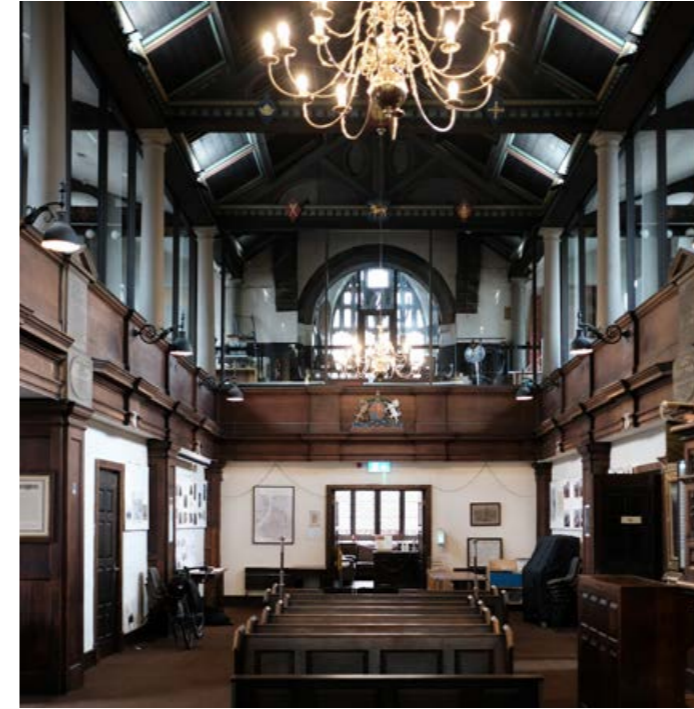
The gallery perimeter is lined with curtain wall glazing, constructed in the 1980s, which serves as an acoustic and visual barrier between the nave and upper floor. The glazing, now dated in appearance, detracts from the building's historic architecture. Removing the glazing could improve the space's acoustics, as the highly reflective glass currently contributes to longer reverberation times.

The historic pews at gallery level would be retained and sympathetically adapted to form desks for co-working use, and the removal of the 1980's glazed screens is proposed, to create a flexible space and seating area for gigs and other events. Also proposed is the removal of the raised access floor at the west end of the gallery – this would be replaced with small lightweight steps to provide access to the bell tower meeting space, or for bell ringing (note that removal of the glazed screens and raised access floor are also common to all options).

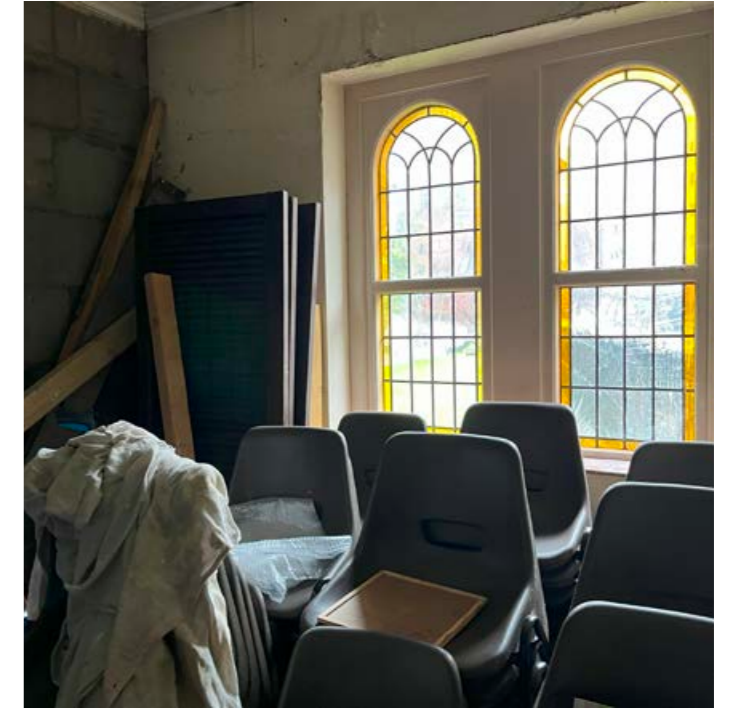
The aisles were remodelled in 1980 to create toilets and office spaces. Closing off the aisles in such a way limits natural light to the nave, which is predominantly lit by clerestory windows. Some of the aisle rooms are used as storage, however, there is an opportunity to do more with these spaces.

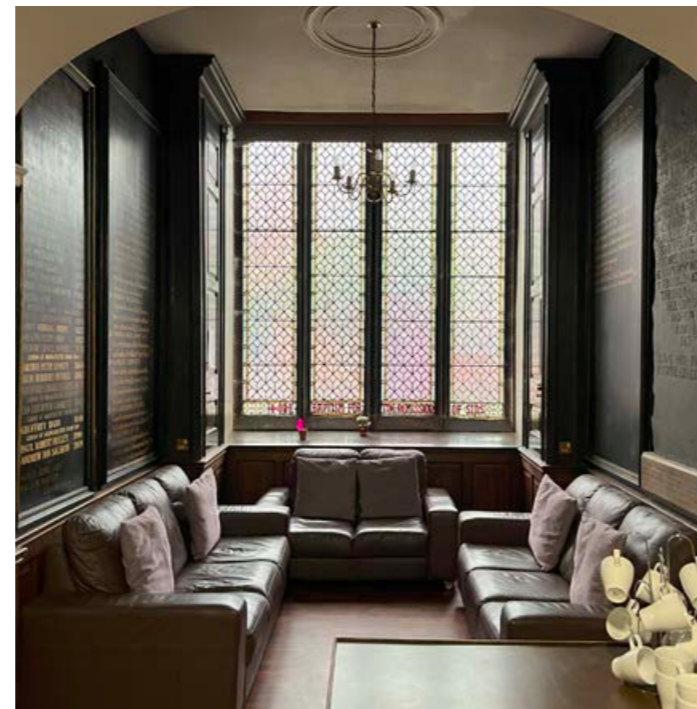
The ground floor tower space is used as a social space for informal gatherings. This area acts and extension to the foyer and kitchenette.

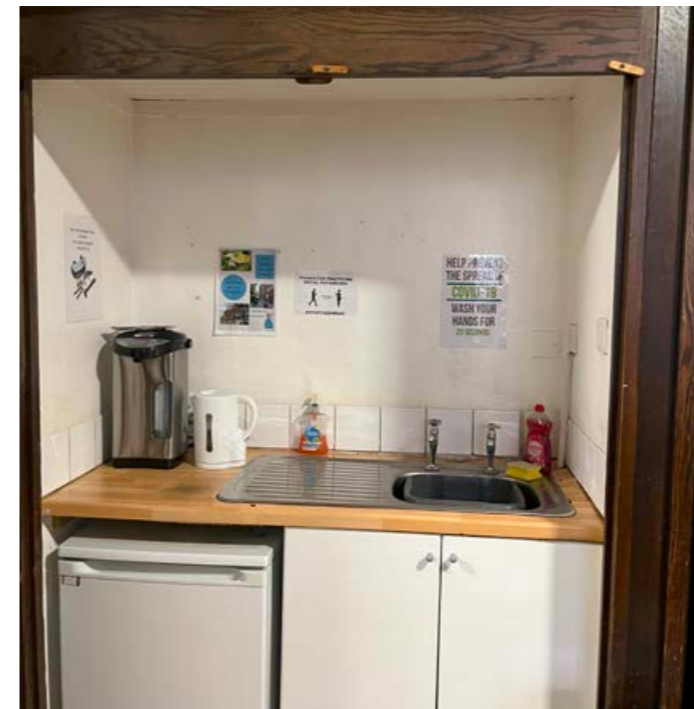
The low-quality kitchenette is one of the first features visible upon entering the church, offering an opportunity to either create a new kitchen space or upgrade the existing facilities.

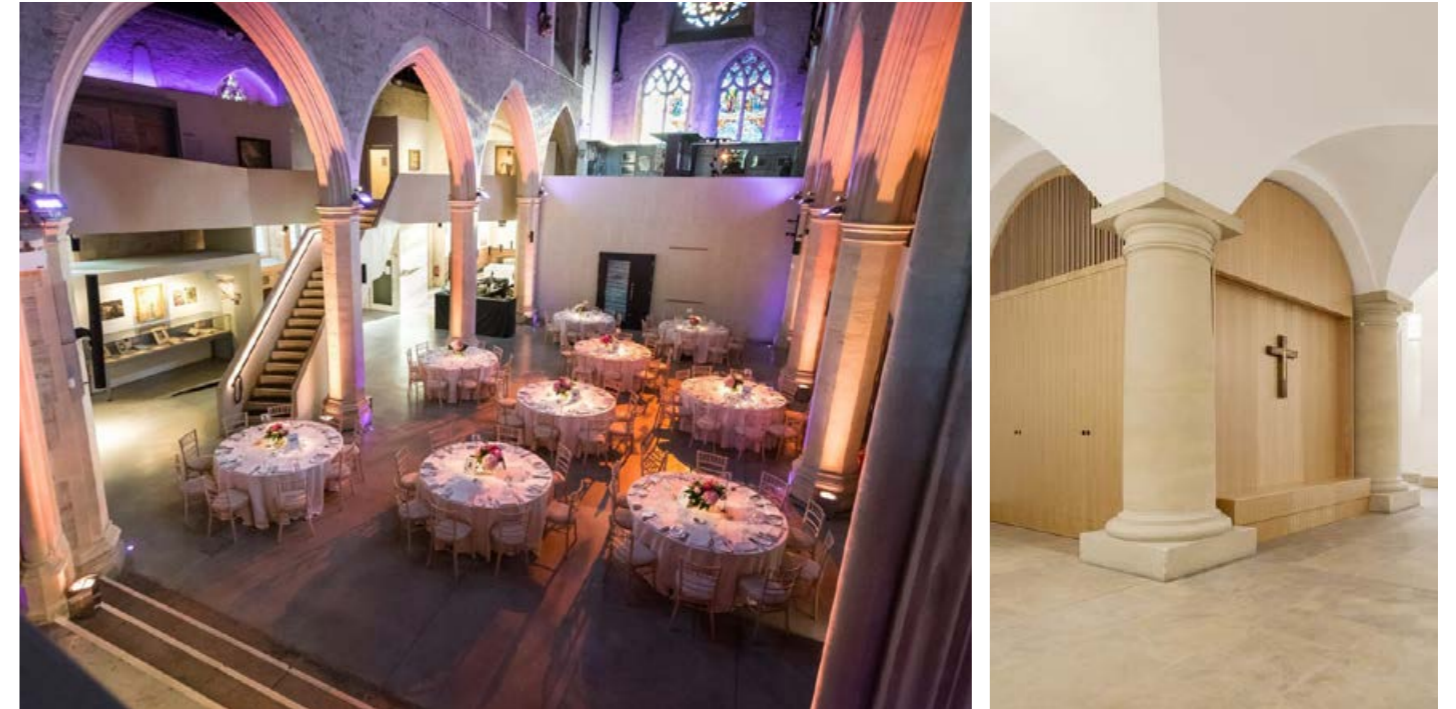
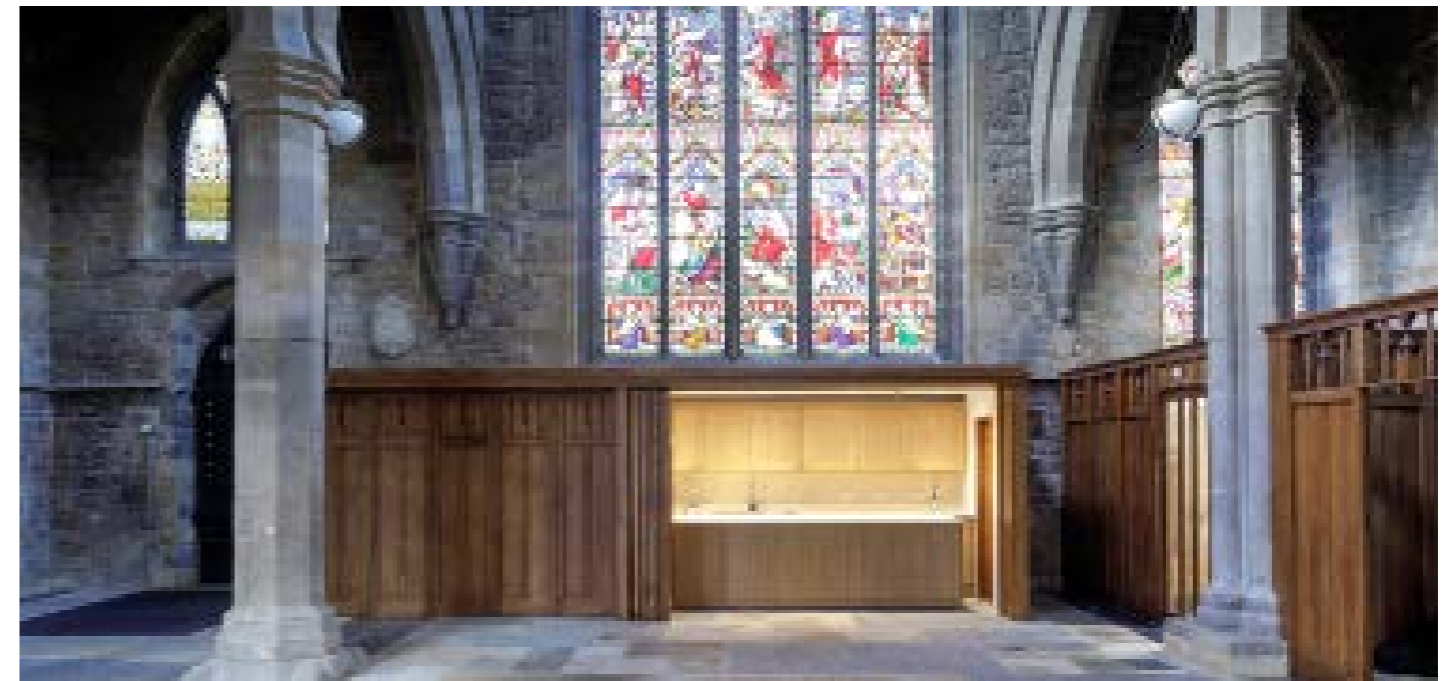
3.3 Option 1 - Ground Floor Plan

The first option explores the opening up of the aisles to create a larger, more flexible nave and allowing natural light to fill the space. The traditional Victorian pews are replaced with smaller, movable pews that maintain the order of the church but can be rearranged for different events.

Using folding doors, a new arrival and orientation space is acoustically and thermally separate from the nave, but can be opened up for larger events. An upgraded kitchen servery is created to provide a facilities to community group meetings or catered events such as weddings.

Smaller spaces are created within the nave using the historic pews, which can be used for meetings or religious reflection. The gallery is remodelled to allow some work and meeting space, in addition to audience seating. The Georgian raked pews are unobtrusively adapted to create individual desks.

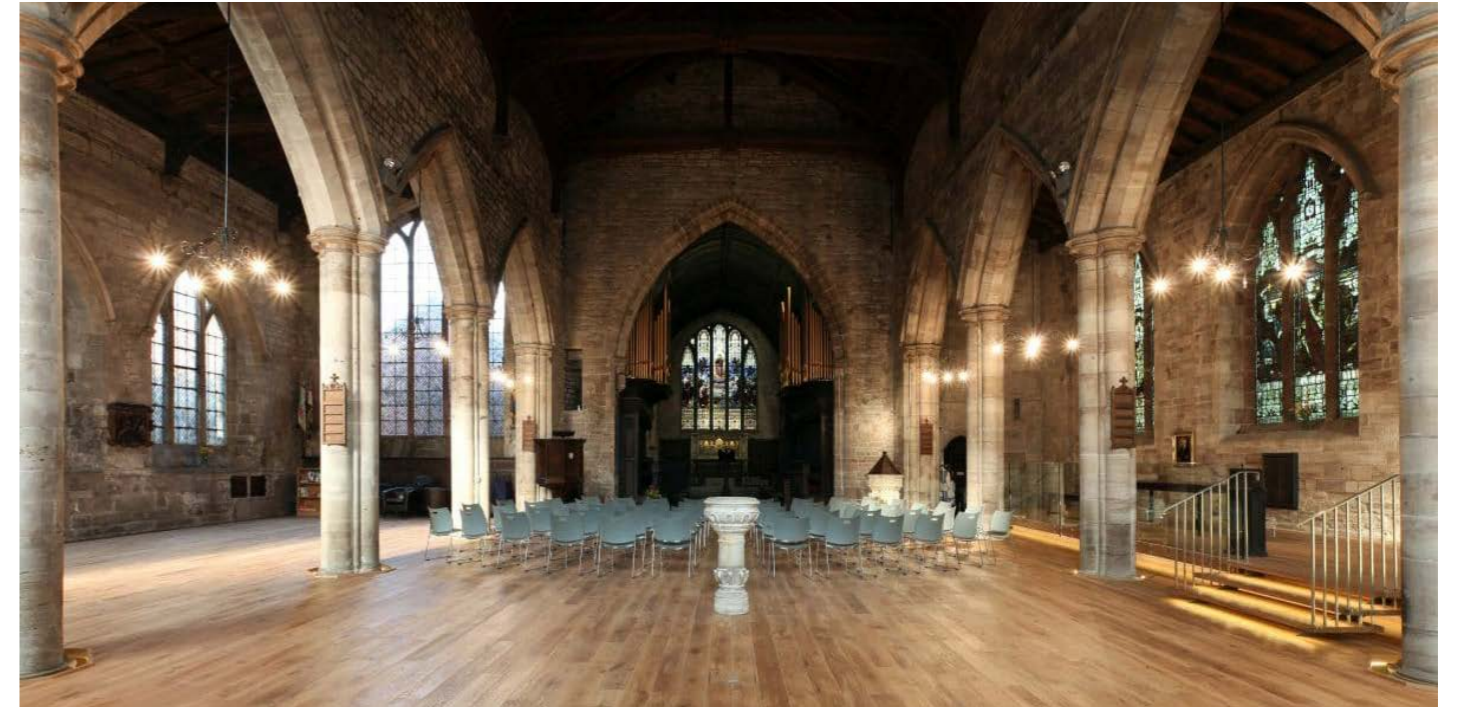
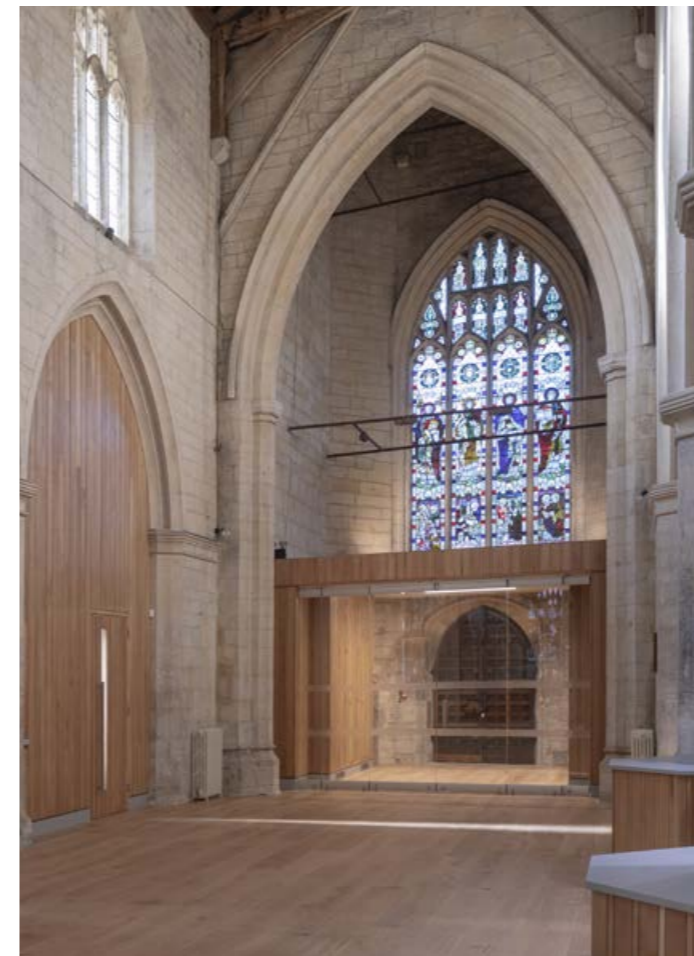
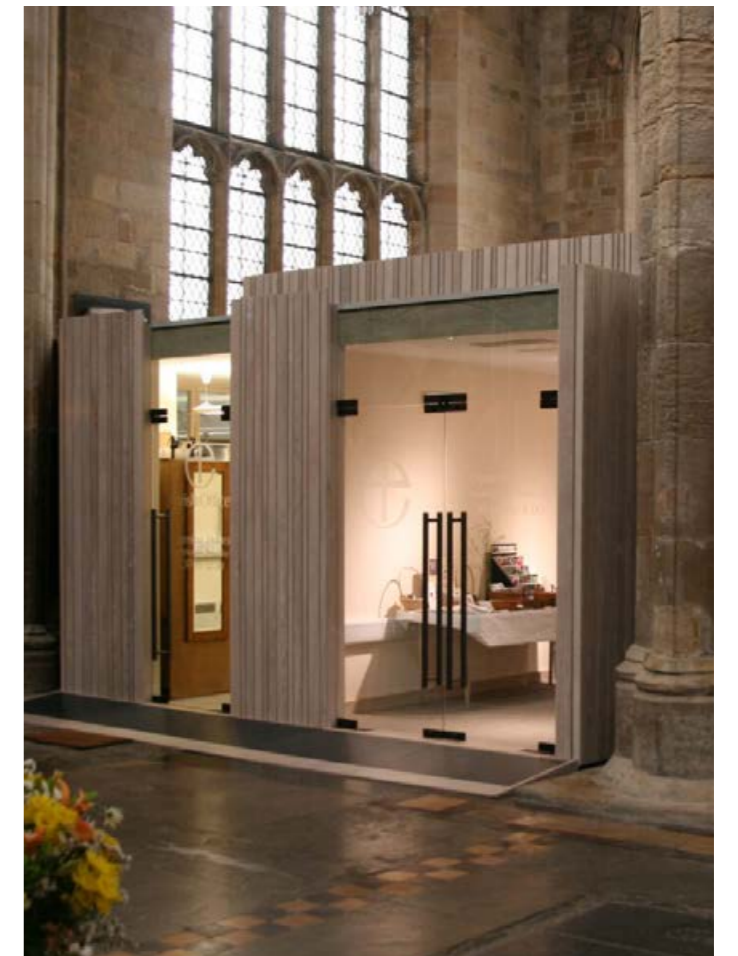
3.6 Option 2 - Ground Floor Plan

The second option builds upon the same principles as Option 1 by opening up the aisles to create a large and flexible liturgical and event space in the nave. A new dedicated community space is created by constructing a small extension that sits within the historic fabric. This intervention allows the space to be acoustically and thermally separate from the nave, but can be opened up for larger events.

Smaller spaces are created within the nave using the historic pews, which can be used for meetings, co-working or religious reflection. The gallery is remodelled to allow some work and meeting space, in addition to audience seating.

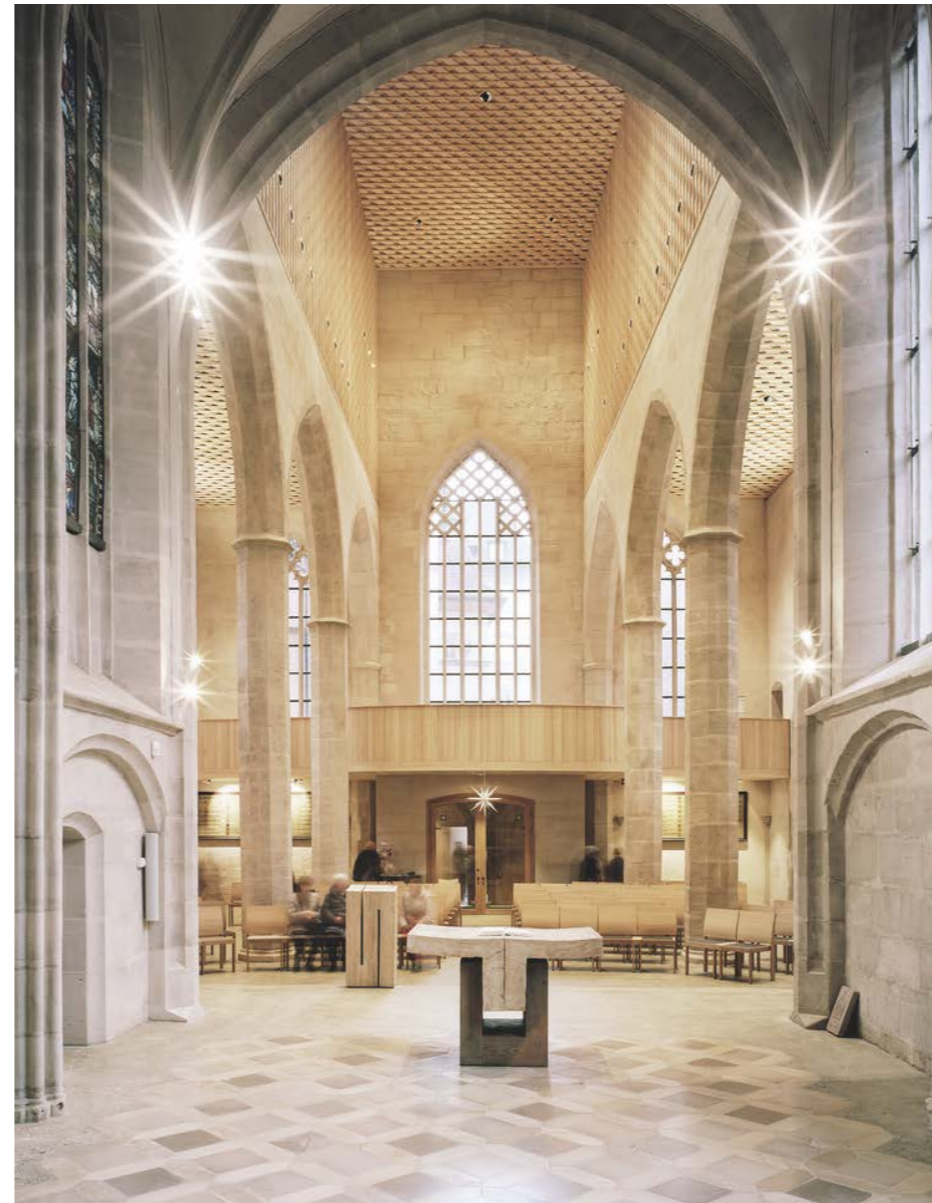
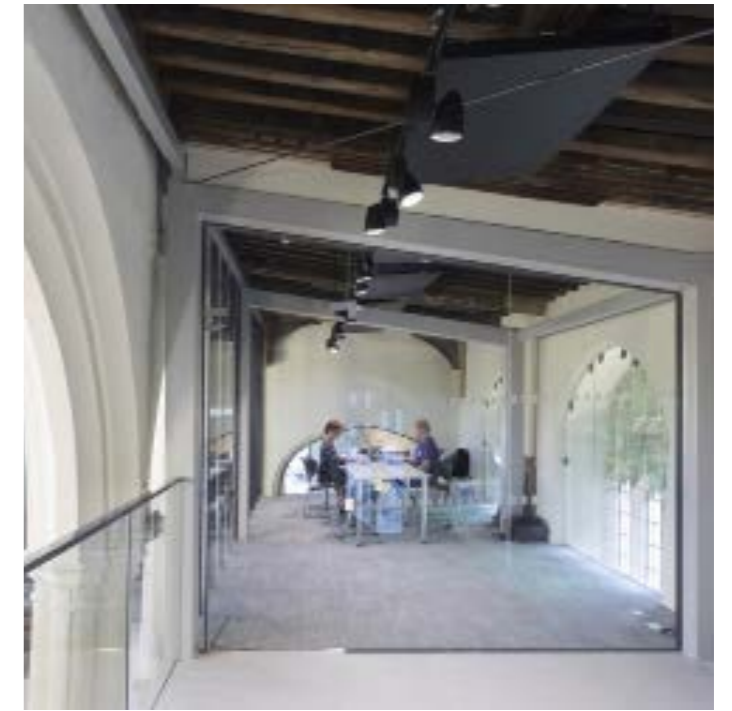
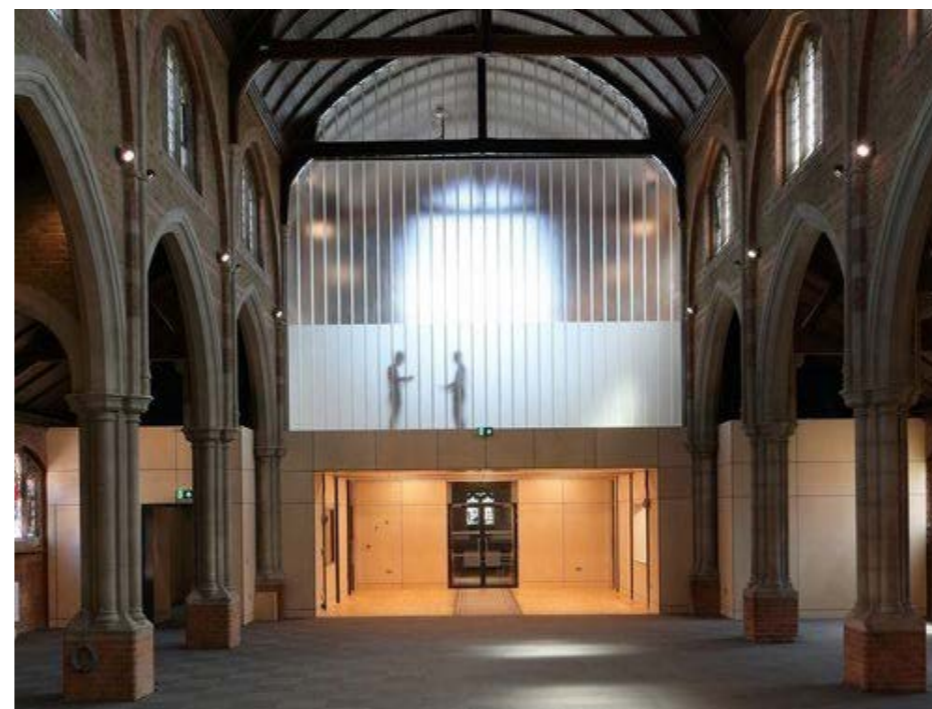
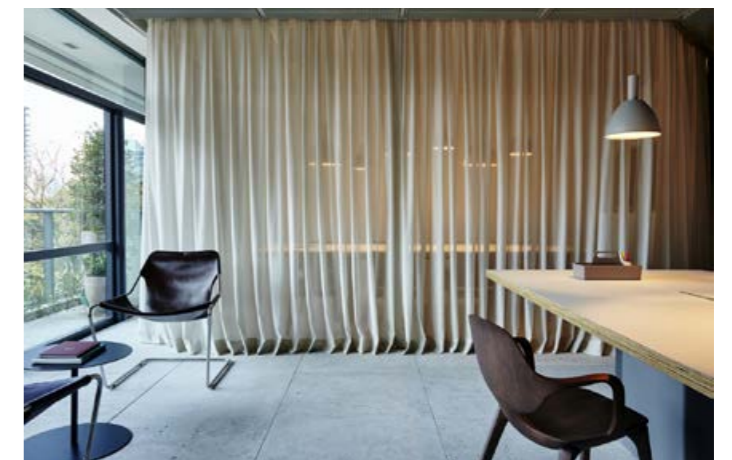
3.9 Option 3 - Ground Floor Plan

The key proposal in this option is to move the line of the gallery forward to create a much larger usable space on the first floor. This area would have considerable co-working / office and meeting room offer, whilst maintaining the pews for informal meetings and audience seating. Acoustic curtains are used on the ground floor to divide the space up depending on the required use.

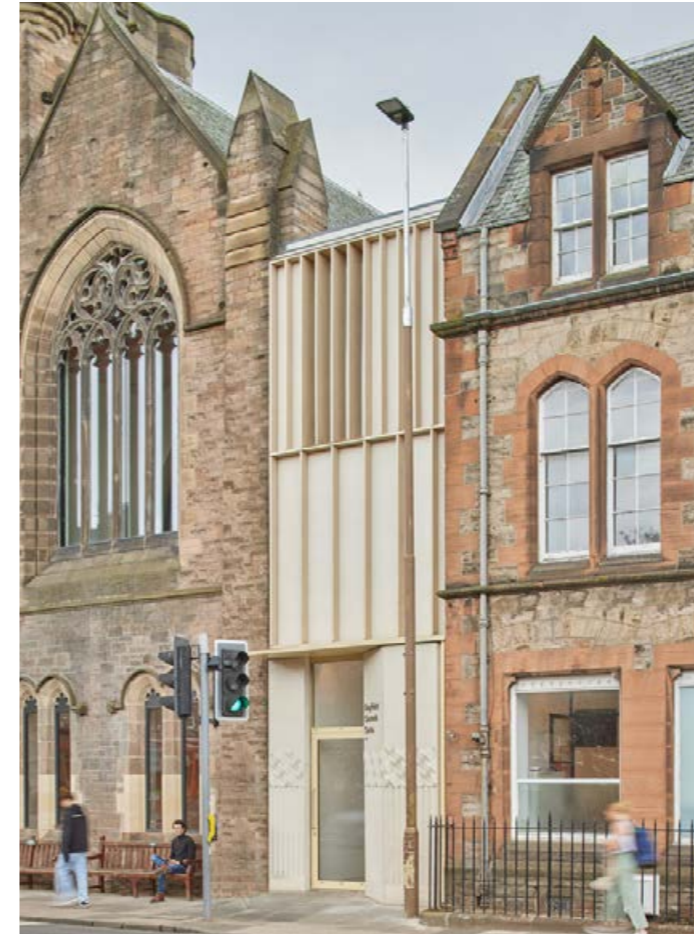
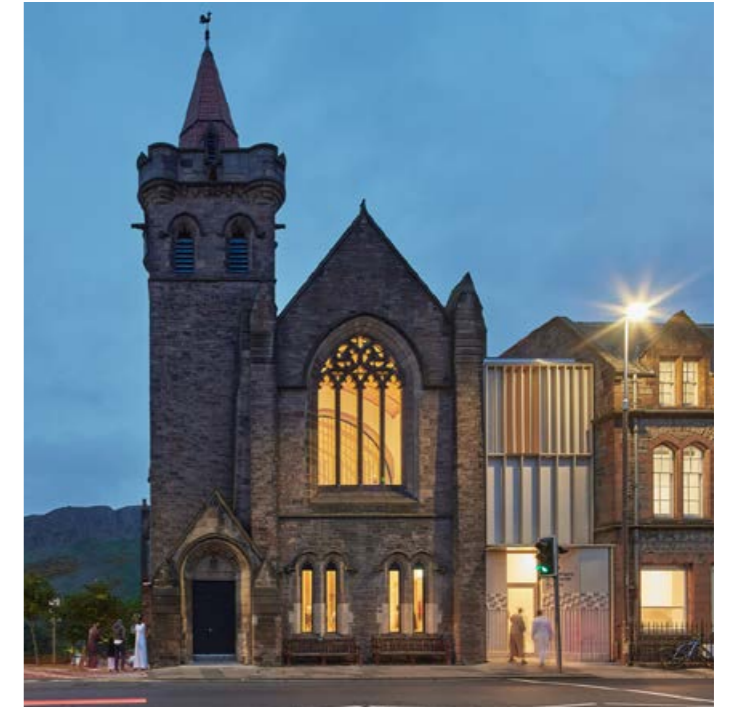
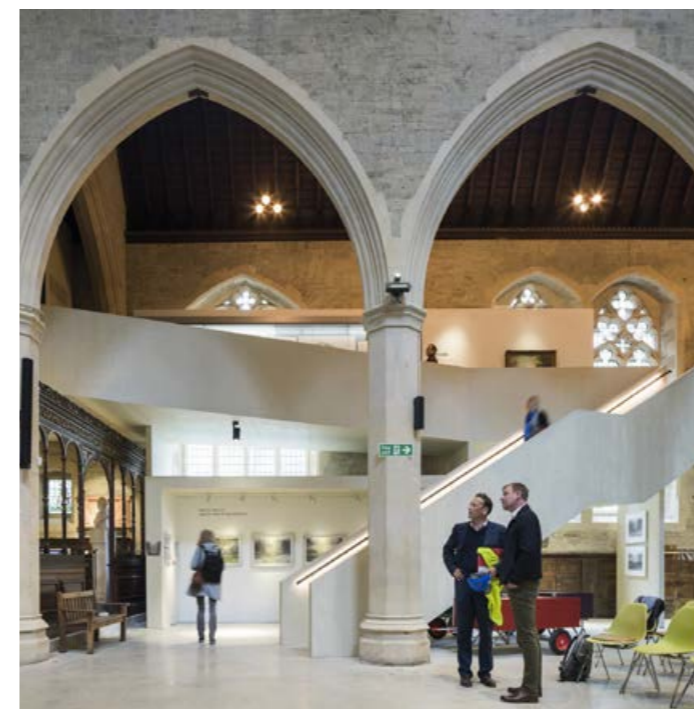
3.12 Option 4 - Ground Floor Plan

The third option tested the idea of an external extension as a means of accessing the gallery, creating the maximum usable area within the building and a clear distinction between old and new. The more recent Victorian extension to the north west of church was considered of lesser historical significance and created an opportunity to explore a new arrival space that fronts on to the public square to the west and provides accessible circulation to the gallery.

A new changing places WC is added to the ground floor, in addition to a flexible classroom and art space.

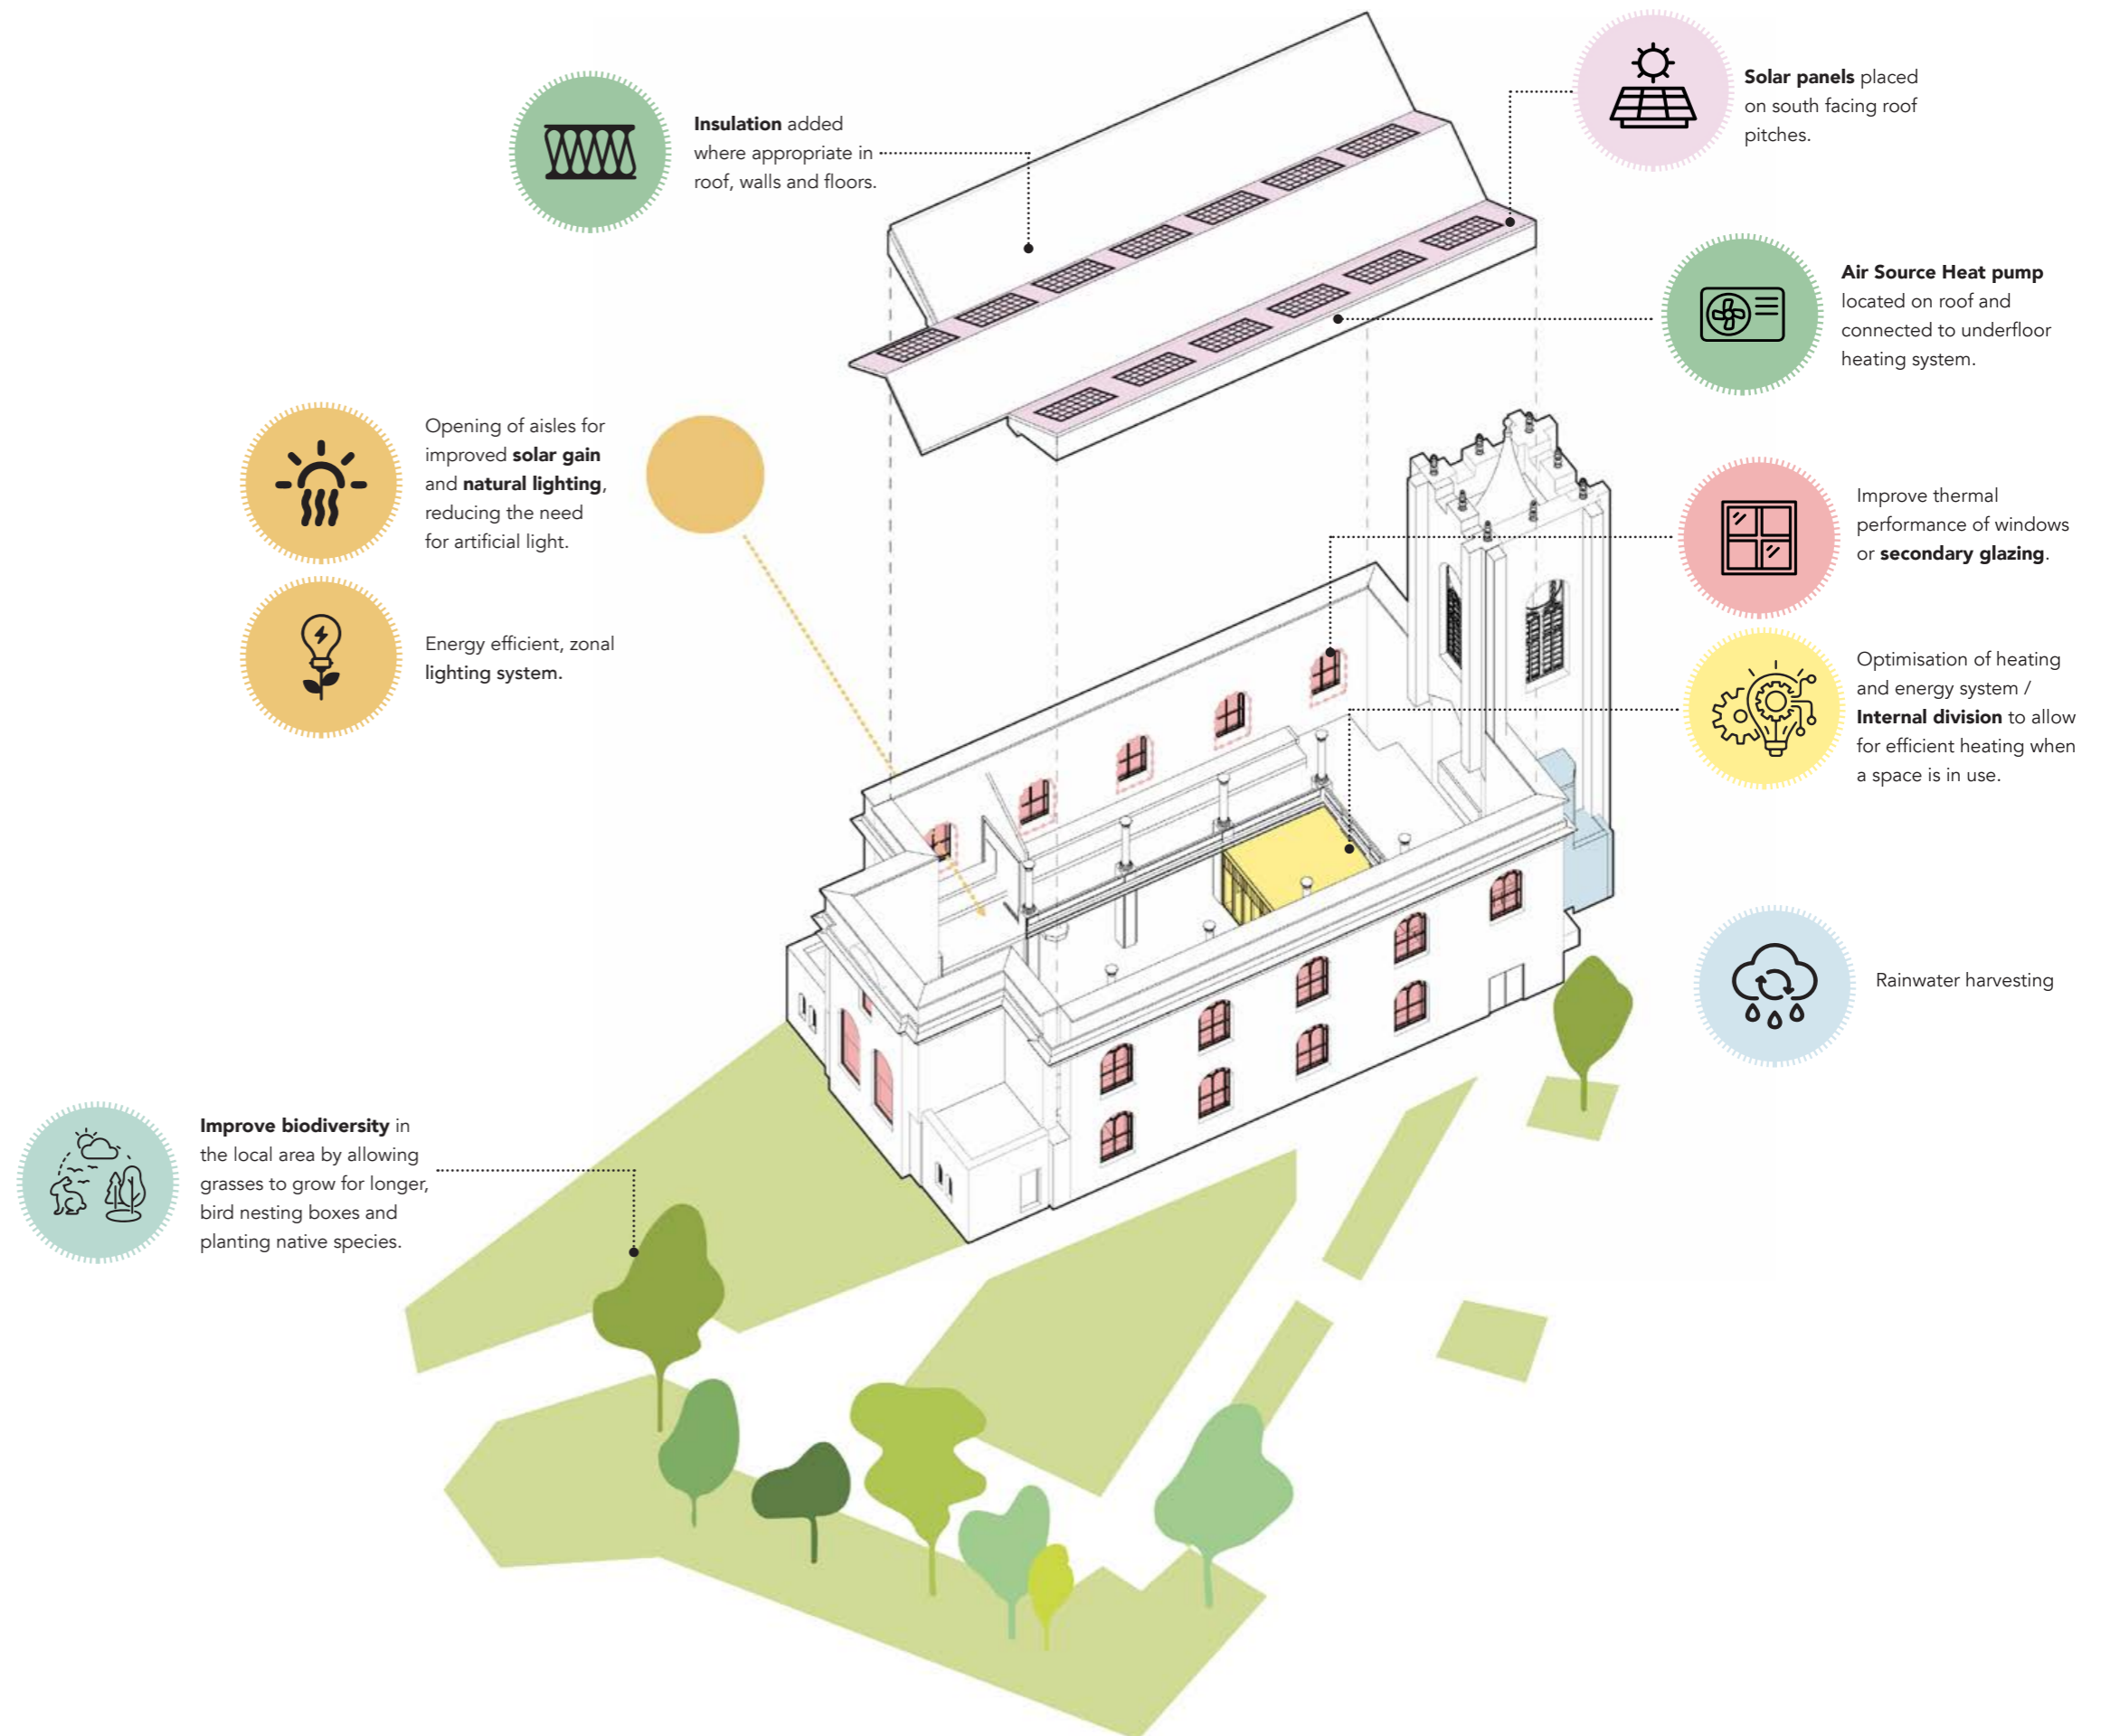
Strategies for improving heating within the church, as well as ways to holistically incorporate renewable green energy sources, have been investigated at a high level during the design process. Services Engineers, Ingleton Wood, appraised the existing services and provided advice on how the energy efficiency of the church could be improved. Their full report is presented in *Appendix 6.2*. Several key technologies were found to be suitable, such as solar panels, air source heat pump, secondary glazing and creating flexible spaces within the church that can be heated only when necessary.

The concepts outlined in the diagram should be thoroughly investigated and refined further with a specialist services consultant to establish their suitability and viability for the site.

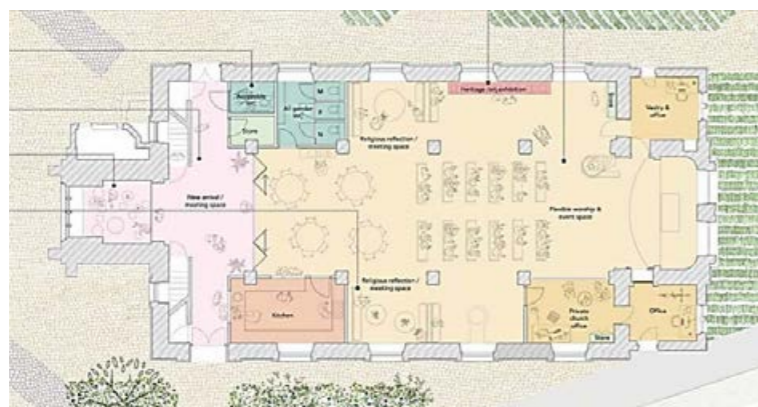
Figure 2.1.1: Proposed ground floor layout, Option 1

The provision of four new WCs is proposed at ground floor to replace the existing pair of WCs, situated to the north-west of the nave, in the former north aisle.

To the south-west of the nave, in the former south aisle, a new kitchen is proposed to replace existing offices.

The proposed Ground floor layout for Option 1 is shown in Figure 2.1.1 below.

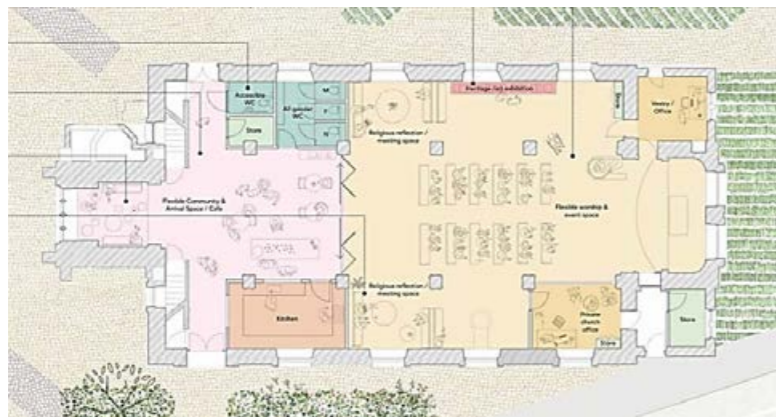
Figure 2.2.1: Proposed ground floor layout, Option 2

In addition, Option 2 includes bringing the line of the internal lobby forwards into the nave, to create a larger entrance lobby and allowing more flexible use for the space it encloses. This new lobby includes a glazed roof at gallery level to create an enclosed single-storey entrance space, with folding doors to allow the floorplan to be opened up during events.

The proposed Ground floor layout for Option 2 is shown in Figure 2.2.1 below.

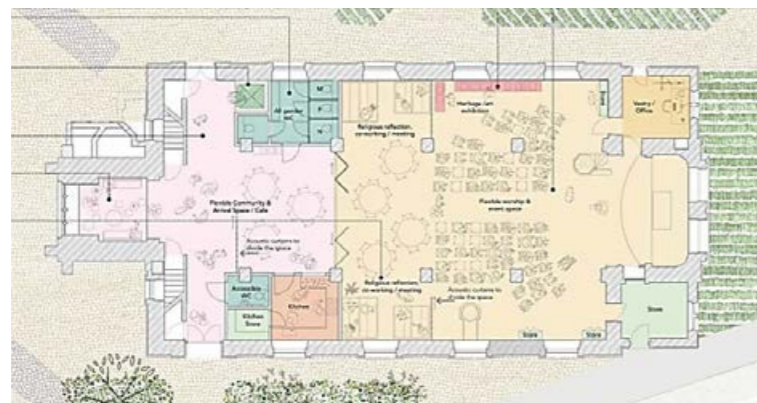
Figure 2.3.1: Proposed ground floor layout, Option 3

The impact of Option 3 on historic building fabric is comparatively onerous, involving similar interventions to Option 2 but also with modifications to the gallery structures. As the roof/ceiling of the lobby would be accessible in this option, vertical loads on the new lobby structure and its footings would be significantly higher. The feasibility of this proposal will be subject to a survey of the sub-floor void and the historic floor beneath, as outlined above for the previous options.

The proposed ground floor layout for Option 3 is shown in Figure 2.3.1 below.

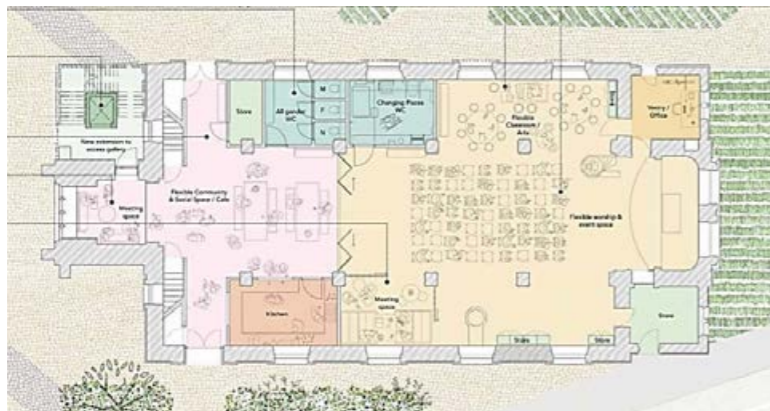
Figure 2.4.1: Proposed ground floor layout, Option 4

In addition to these items, an external extension is proposed in the northwest corner of the building, adjacent to the tower. This extension will include a staircase and a lift, greatly enhancing access to the gallery space. Access to the gallery level will also be possible from the outside of the building, for times when the ground floor of the church is not in use, or to keep the users of the two levels separate.

The proposed ground floor layout for Option 4 is shown in Figure 2.4.1 below.

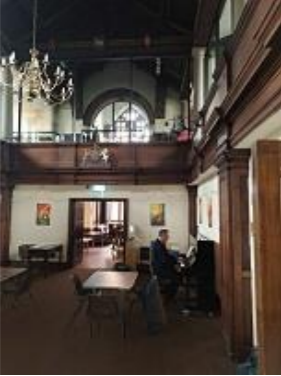
<p>High Level Lighting</p>
<p>Photo MEP 004</p>

E4	Internal & Emergency Lighting Systems	Upgrade of lighting & emergency provisions	The emergency lighting and EXIT lighting provision throughout the building does not comply to current regulations so is urgent to upgrade. The general lighting could do with improvements throughout.	B/C	2/3	10000	15000		£25,000.00
E5	Fire Alarm System	Upgrade of existing fire alarm system	Upgrade the fire alarm system in the church to give better protection and comply with current standards.	B	4	5000			£5,000.00
E6	External Lighting	Upgrade external lighting	Replace existing external lighting with new LED luminaires to improve the visual impressions of the building.	B	3		3000		£3,000.00
E7	Replace Church Electrics	Rewire of Church	We would recommend a rewire of the church as part of an overall improvement upgrade to systems.	B	3		30000		£30,000.00
M1	Church LTHW Pipework & Distribution	The pipework supplying the heating is generally past its normal working life with some in poor condition and therefore there is significant risk of leaks throughout the building.	The distribution in the property is made up of different metals therefore it is likely that galvanic corrosion has occurred. This will cause the pipework degrade internally and significantly increase the likelihood of leaks.	C	3		65000		£65,000.00
